SUBJECT: Analysis of the Apollo Entry  
Monitor System's  $\Delta V$  Counter  
Case 320

DATE: April 16, 1969

FROM: D. O. Baechler  
R. Lindner, BTL

ABSTRACT

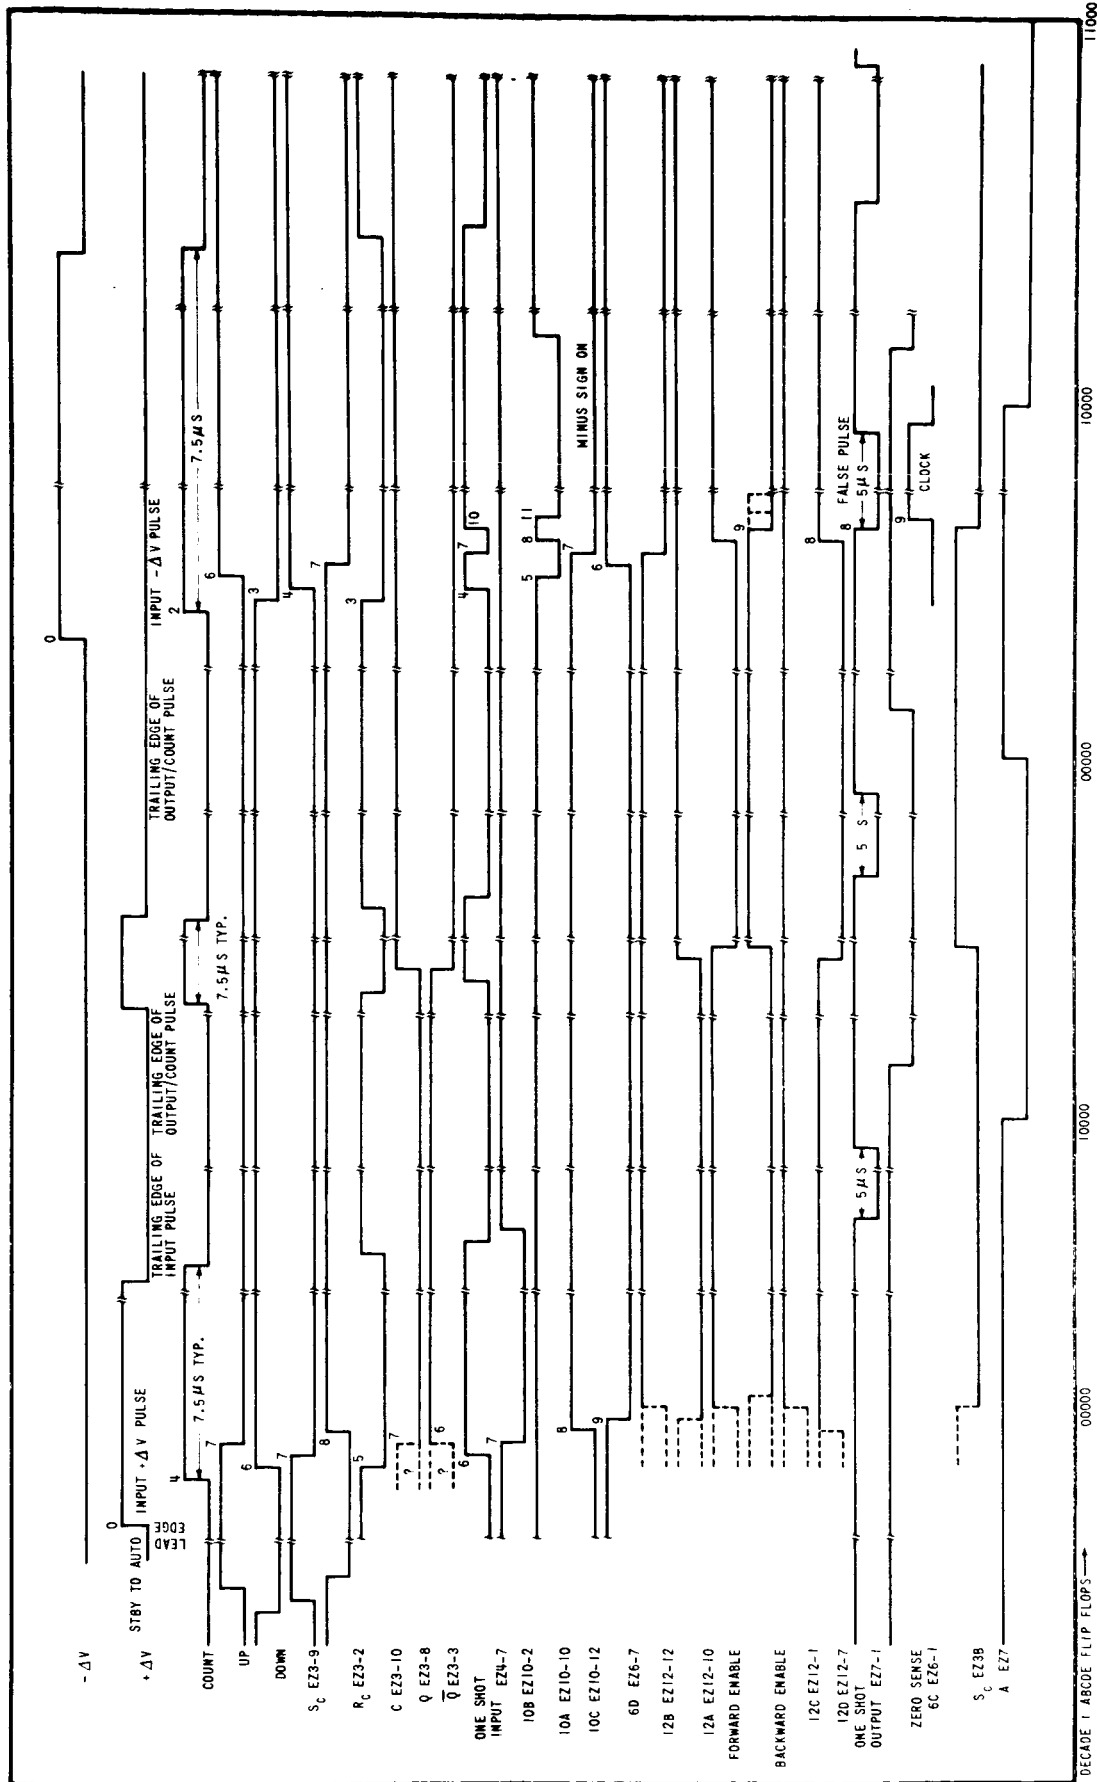
FIGURE 3 - LOGIC RACE

A situation that could cause a false jump has been described by R. A. Harris of Autonetics and is shown in the timing diagram of Figure 3. Starting from an all zero condition in the display, two  $+\Delta V$  pulses are followed by a  $-\Delta V$  pulse resulting in the backward enable signal being still high when a clock pulse arrives at the backward transfer gate. Since the output of the backward transfer gate is interpreted as a count pulse in the next decade, subsequent decades may count to nine.

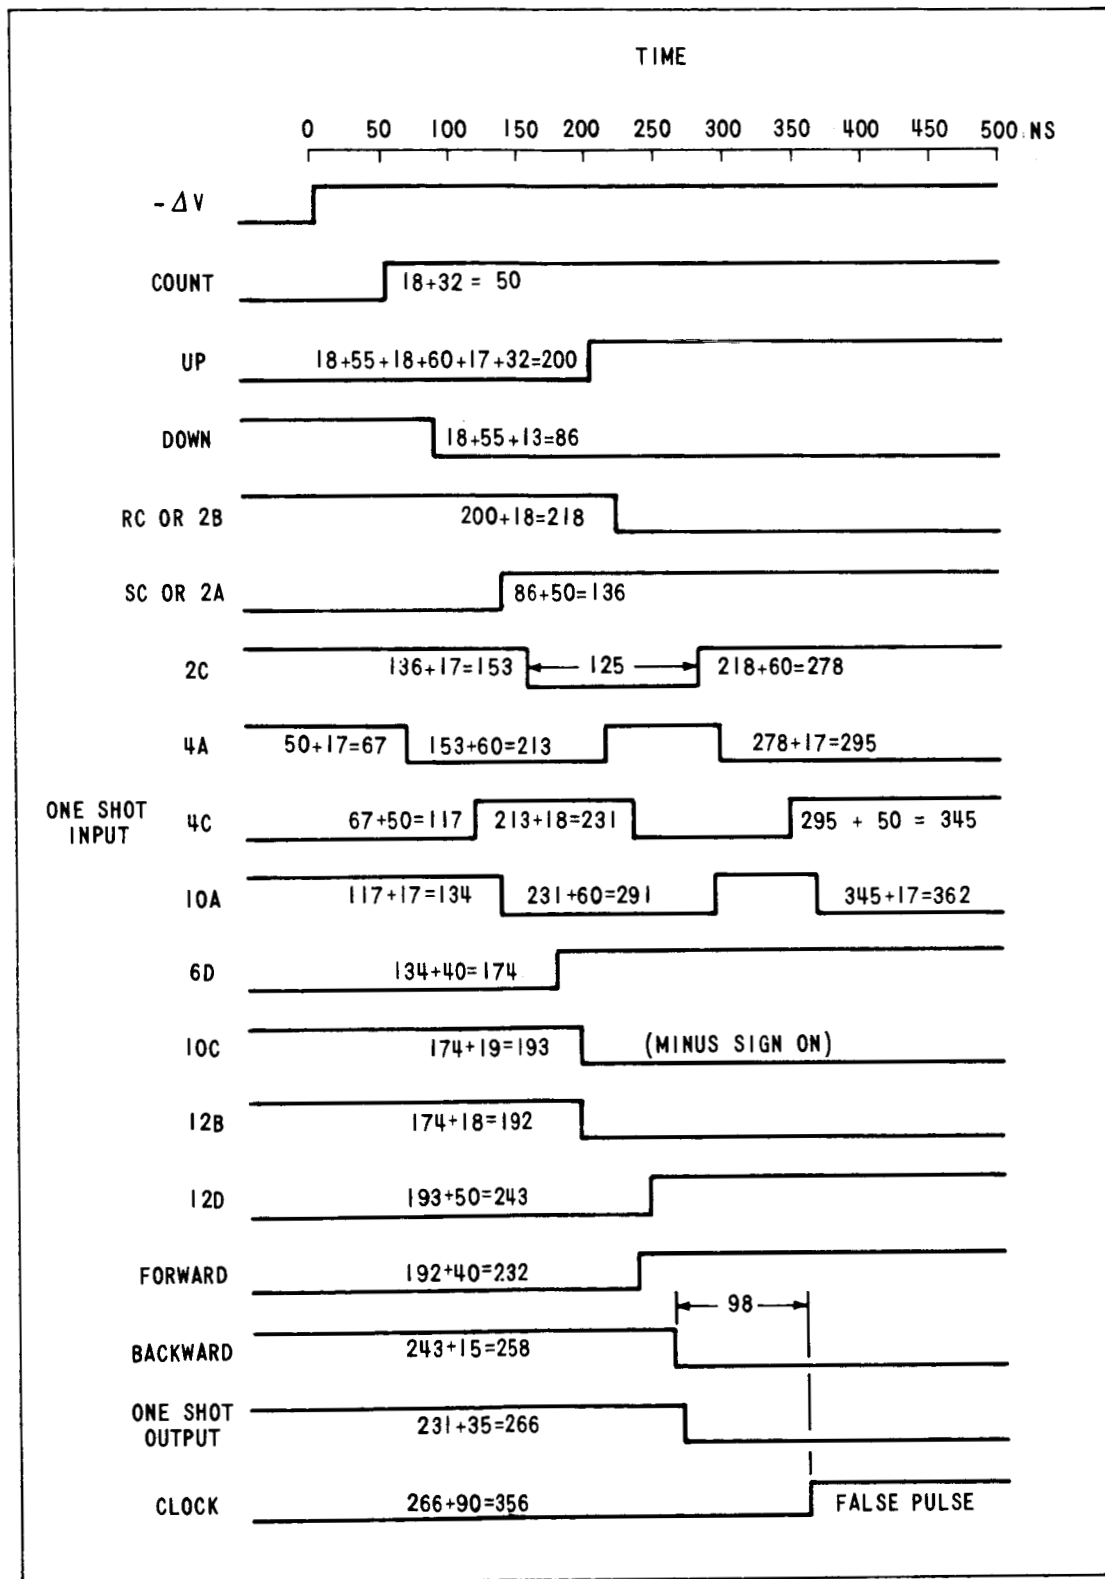
FIGURE 4 - ASSUMING TWO  $+\Delta V$  PULSES HAVE ENTERED FROM AN INITIAL ALL ZERO CONDITION AND IS FOLLOWED BY A  $-\Delta V$  PULSE

This situation has been examined in greater detail by using maximum propagation delay times. Starting with  $t=0$  at the leading edge of the  $-\Delta V$  pulse and using the same logic states as in Figure 3 up to that time, the pulse times are recorded in Figure 4 for each point in the logic. In particular, it can be seen in Figure 4 that because of unequal gate delays from  $-\Delta V$  to the UP and DOWN points, a 125ns negative going pulse is found at the output of gate 2C. Then since the COUNT pulse has arrived at gate 4A before this, a short pulse preceding a slightly shortened 7.5 $\mu$ s pulse is caused at the input to the one shot. This short pulse falls to zero at 231ns, triggering a one shot pulse at 266ns. The pulse from the one shot is inverted by gate 1A to become a positive clock pulse for both the counter flip-flops in decade 1 and the transfer gates to decade 2. This is an unwanted or false pulse. However, since the clock pulse must charge a 70pF capacitor at each flip-flop, the switching delay of gate 1A can be 90ns, giving a time of 356ns before the clock pulse can reach the backward transfer gate 12B.

The equations can be used with different delay times to check if  $t_{\text{PHL}}(\text{BE}) > t_{\text{PLH}}(\text{C1})$  which can produce a -9.2 display or if  $t_{\text{PHL}}(\text{BE}) > t_{\text{PLH}}(\text{C2})$  which can produce a -99.2 display. But using the above values, the margins against these occurrences are 98 and 201ns respectively.

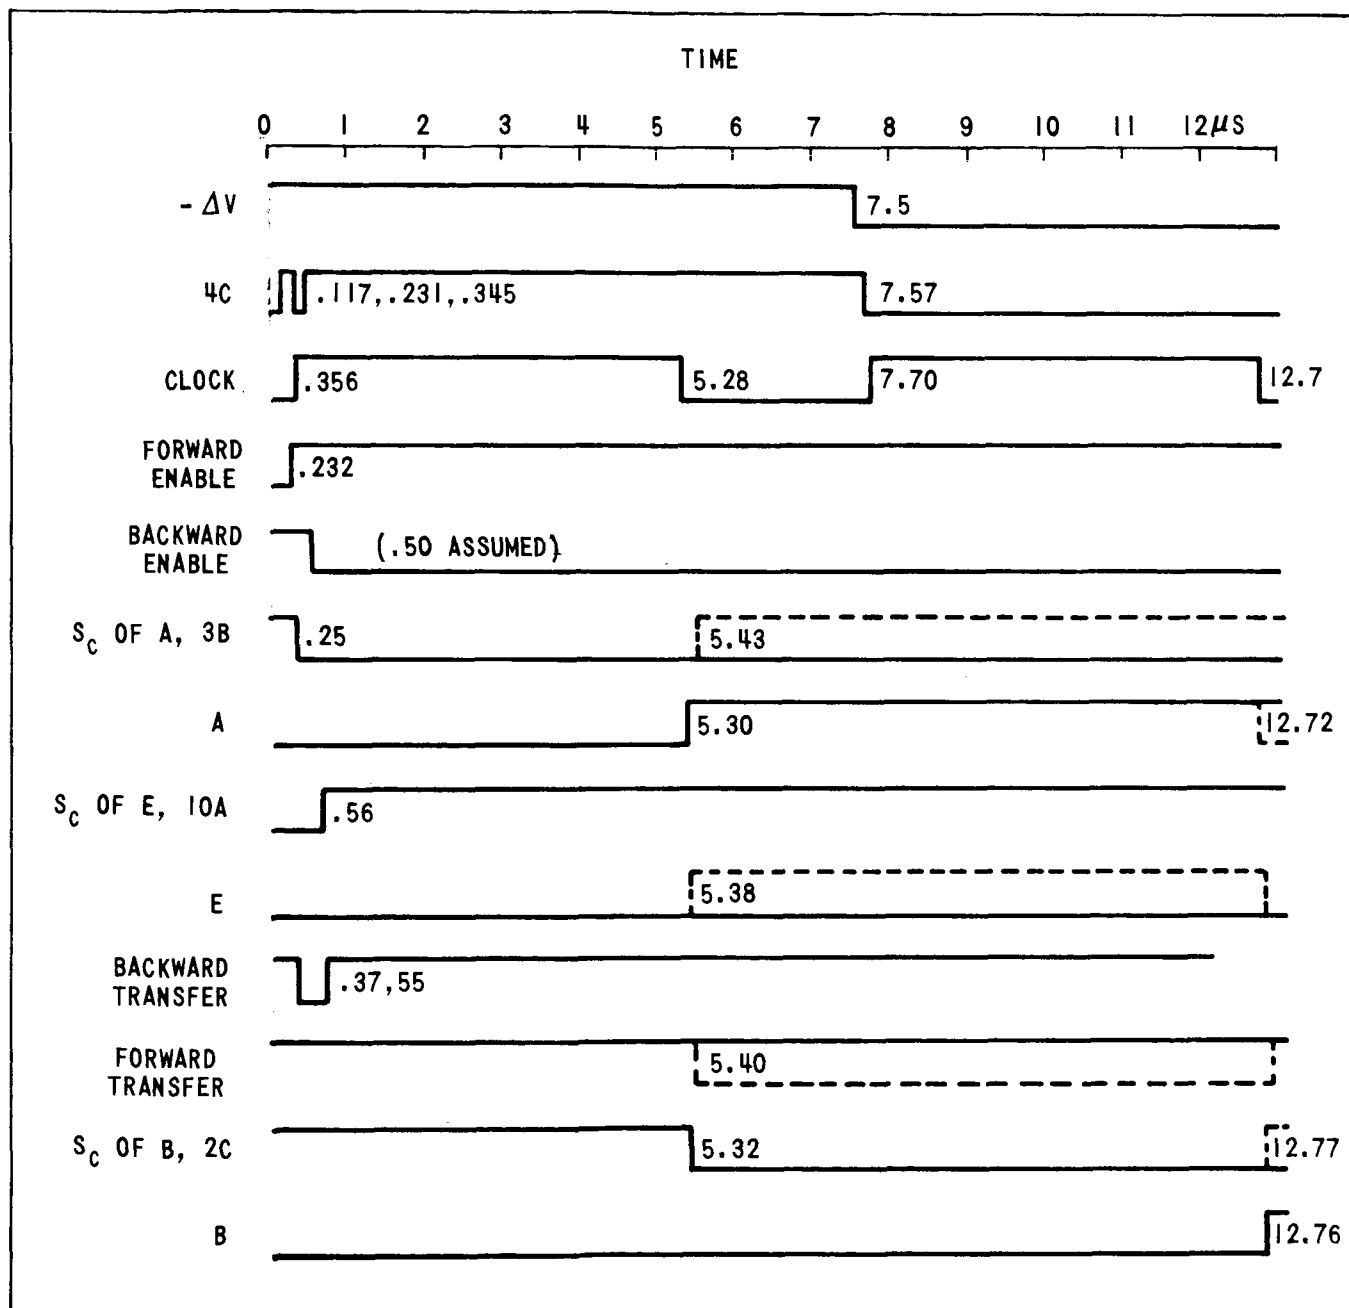
FIGURE 5 - WAVEFORMS SHOWING POSSIBLE JUMP TO -100.

In order to explain how the -100.4 jump may have occurred, another situation was suggested by Autonetics. To describe it, the longer time scale of Figure 5 is needed. In this figure, assuming  $t_{\text{PHL}}(\text{BE}) = 500\text{ns} = 0.50\mu\text{s}$ , all the pulses indicated by the solid lines would occur and the display would be -99.1 after  $5.3\mu\text{s}$  and -99.2 after  $12.8\mu\text{s}$ . The dashed lines represent the pulses if the following situation occurred. The  $S_{\text{C}}$  line of flip-flop E is low for a period of time ( $\sim 2\mu\text{s}$ ) while the clock is high. From the time  $0.56\mu\text{s}$  this  $S_{\text{C}}$  line goes high causing its  $R_{\text{C}}$  line to go low. Then at  $5.28\mu\text{s}$  the clock goes low, triggering flip-flop E. The result should be that E remains zero. If, however, the charge on the set capacitor has not leaked off in this  $4.72\mu\text{s}$  period (it should discharge in  $2.2\mu\text{s}$ ) the trigger would find both set and reset capacitors charged, resulting in an indeterminate condition. If the less likely result prevailed, flip-flop E could set. This would then cause a forward transfer pulse at gate 12B at the time  $5.4\mu\text{s}$ . The display would now be -99.(AE) after  $5.3\mu\text{s}$  and -100.(B) after  $12.8\mu\text{s}$ . The (AE) and (B) represent scrambles since they are not number codes.

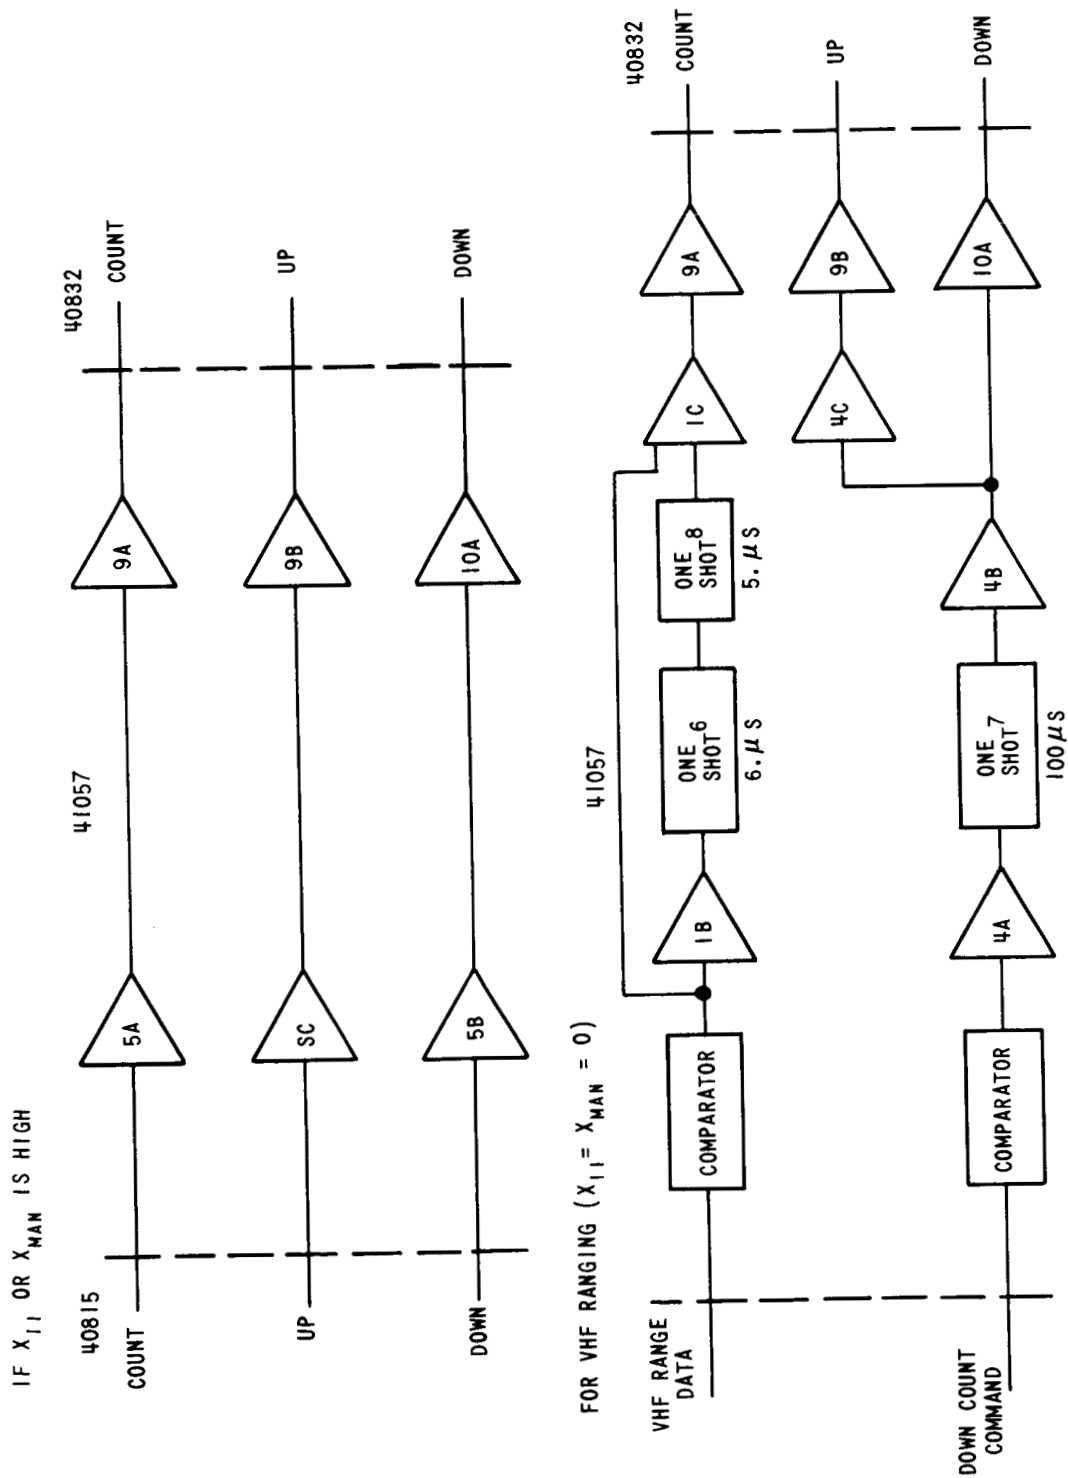
FIGURE 7 - USING VHF RANGING LOGIC

For CSM 106 VHF ranging can also use the same counting logic. As shown in Figure 7, if either  $X_{11}$  or  $X_{MAN}$  is high, the VHF logic is simply a pair of gates inserted at the COUNT, UP and DOWN points of Figure 2. The false pulse will still occur and the jump to -99.2 or -100.(B) still should not (but might) occur. In fact, due to the slight difference in delay through gates 5A and 9A of Figure 7, compared to that of gates 5B and 10A, the margin against false backward transfer is increased from 98ns to 122ns.

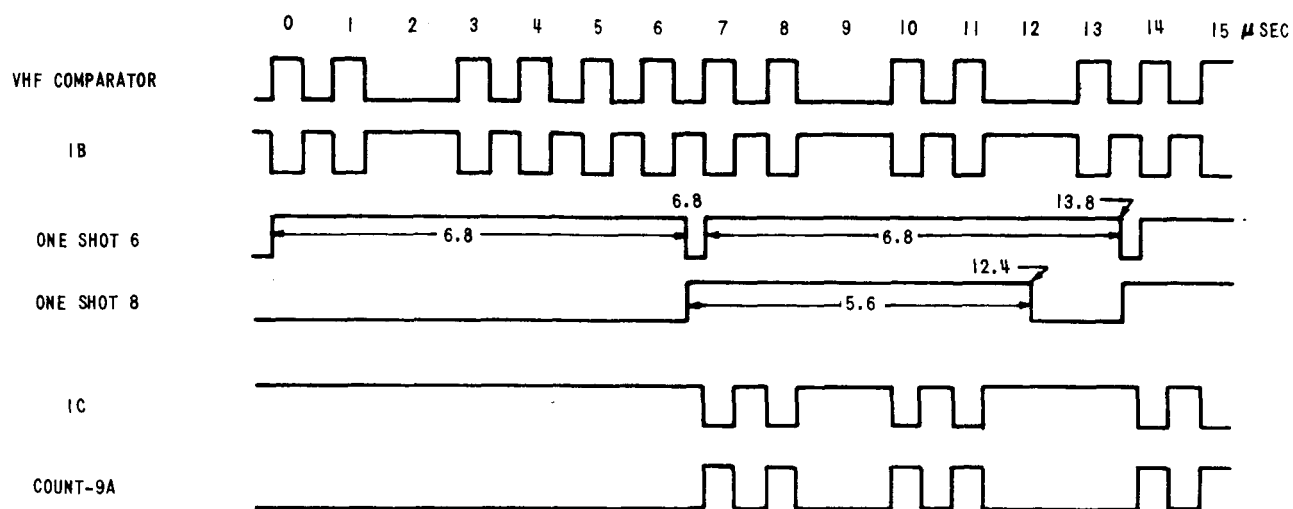
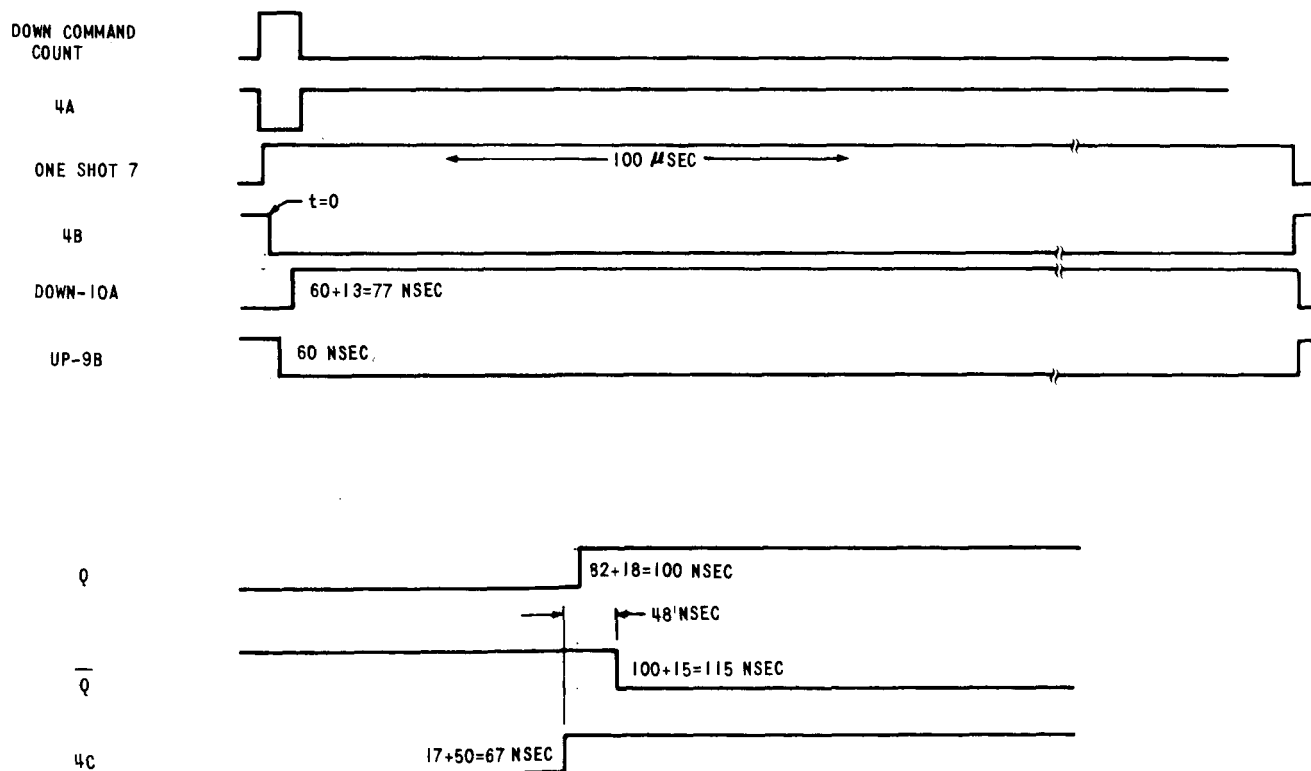
FIGURE 8 - TIMING FOR VHF RANGING

At the bottom of Figure 7, the VHF logic is shown for the case when VHF ranging is being done. Figure 8 shows the appropriate pulse trains. The VHF data was assumed to be amplitude modulated but frequency modulation could as well be assumed. The down count command would forward enable the counter for almost 100 $\mu$ s. Since the UP pulse goes low before the DOWN pulse goes high, gate 2C of 40832 does not go low. Also, the one shot 6 delays any COUNT pulse for 6.8 $\mu$ s. Either fact is sufficient to prevent a false clock pulse. In addition, flip-flop 3 now clocks on the present down count command, assuming the command came at about the same time as the VHF data.

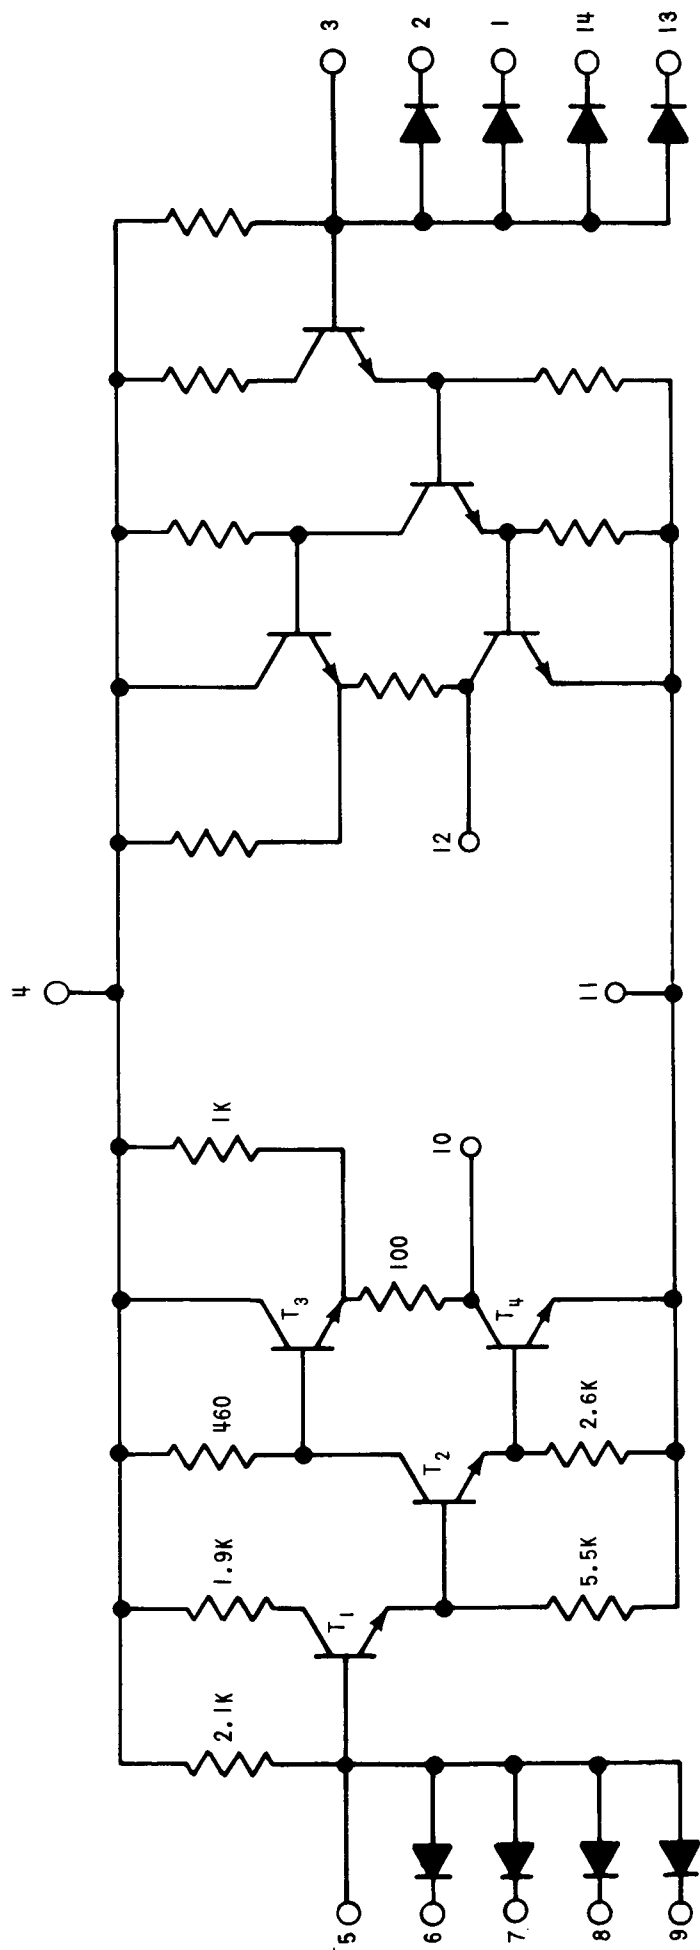
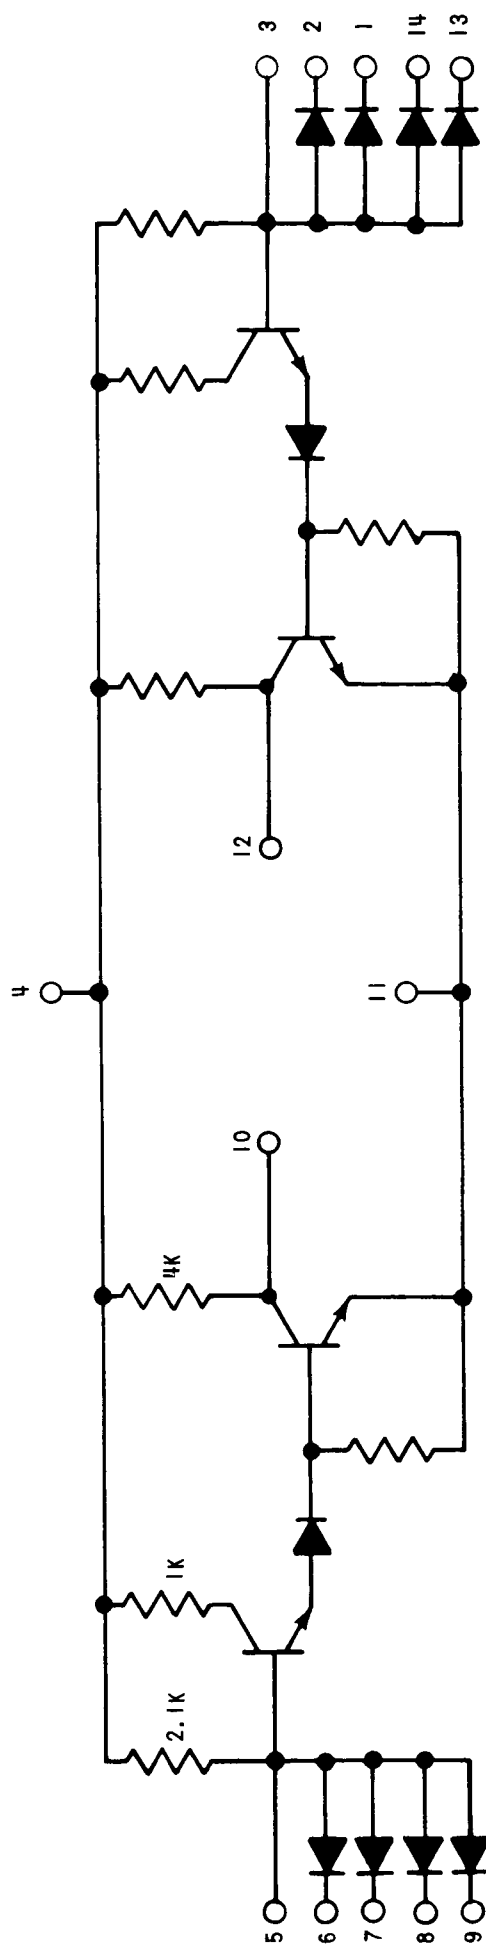
FIGURE 9 - SIGNETICS NAND GATE AND DRIVER

A commonly used gate in the EMS is the SE156J driver gate. This gate has an active pull-up due to transistor  $T_3$  in Figure 9. An active pull-up is necessary when driving lines with a large capacitive load. However, the active pull up also makes the gate a potential noise generator due to internal timing differences. Thus, when using the gate it is recommended practice to have a by-pass capacitor from  $V_{CC}$  to ground, connected close to the package. Also, when there is no capacitive load there is no need for the active pull-up driver and it should not be used.

Due to practical problems of package layout and device qualification it would seem advisable to recommend the replacement of only 24 of the SE156J packages. These packages are the ones in which neither driver is used for high fan-out and are indicated in Table 1. The replacement is the SE116J which as mentioned has the same pin designations and thus is a simple one-for-one replacement.
